Test report: 18-20PO Box 285, Kumeu, Auckland, New Zealand
Phone: +64 9-415 2800 Mob +64 21-977 876

Performance tests on Alfrex solid aluminium panel cassette cladding system, in accordance with AS/NZS 4284:2008 testing of Building Facades to some parameters from draft EM7

Project: Alfrex cassette panel system

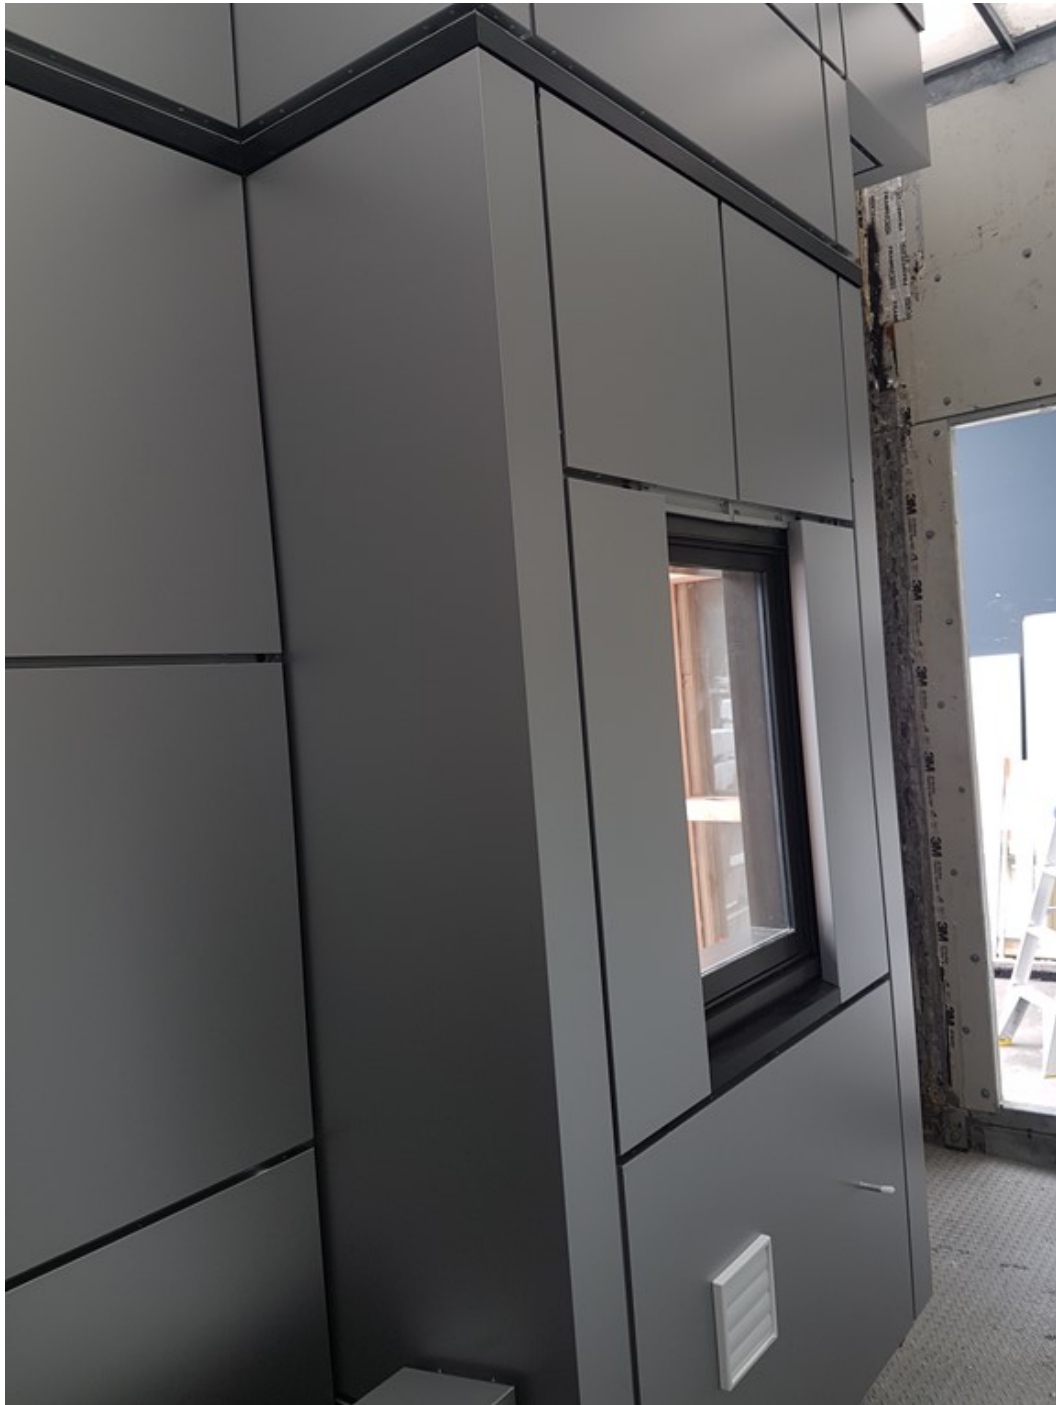
Figure 1: Alfrex cassette panel system under test

The system was installed into a 3.72 m wide, by 3.36 m high timber-framed opening of the test booth by CSNZL. See Figure 1.

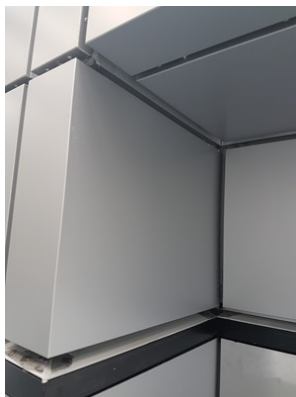
Figure 4: Soffit/wall junction section detail

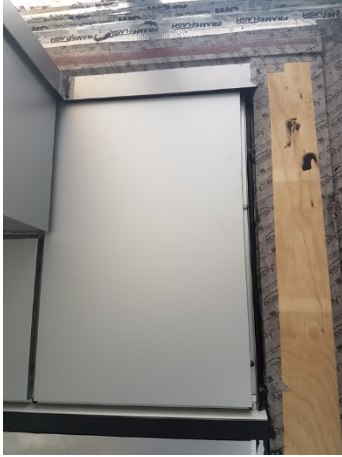
Figure 5: Interstorey junction section detail

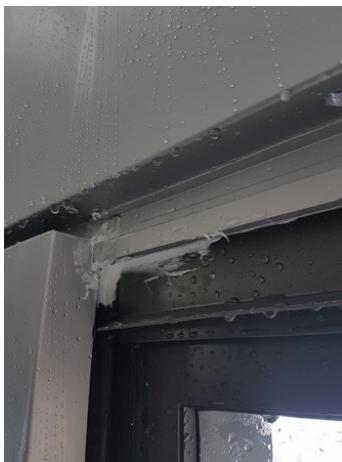
Figure 6: Window head section detail

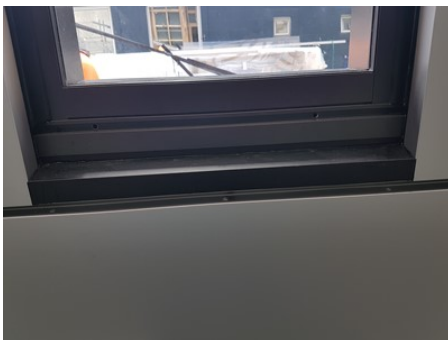
Figure 7: Window sill section detail

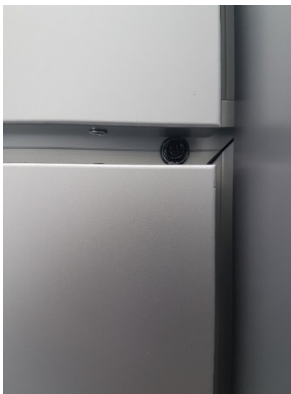
Figure 11: Internal corner plan detail

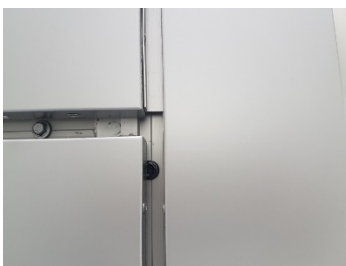
Figure 13: Vertical junction plan detail

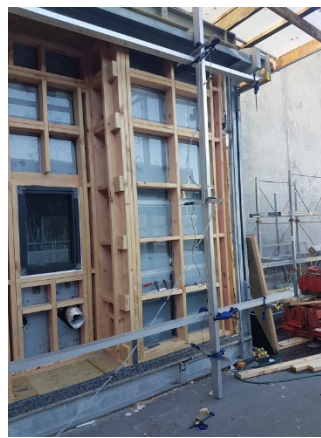
Figure 14: Photo showing location where displacement transducers were placed on full-height timber stud

In accordance with the test procedure specified, a set of displacement transducers was positioned to record localised displacement and net deflection at the outer limits, and at mid-span of the nominated timber stud. The stud nominated is shown in Figure 14, chosen as the only full-height single stud, assumed to show the greatest deflection.

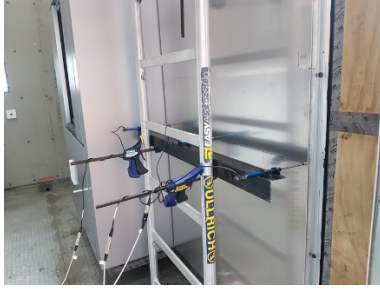
Figure 15: Set of three horizontal transducers setup at the vertical mid-point between stiffeners on a cladding panel.

(As noted above, this testing was performed after the water tests, since it required forming holes in the air barrier). Locations for the measurement of the cladding panel movement were nominated. This involved a horizontal line of transducers on the stiffener, and also across the middle of an un-stiffened panel. The effect of the acrylic air barrier was removed, by forming large holes in it, to allow a pressure to be developed across the cladding as can be seen in Figure 15.

A rigid structure was erected inside the booth to enable measurements of displacement of the cladding to be made, while isolating the transducers from movement in the booth walls.
